Manhole Inspection Summary

Manhole # S49CC_012MH

Insp Date: **2/19/08 2:49 PM**

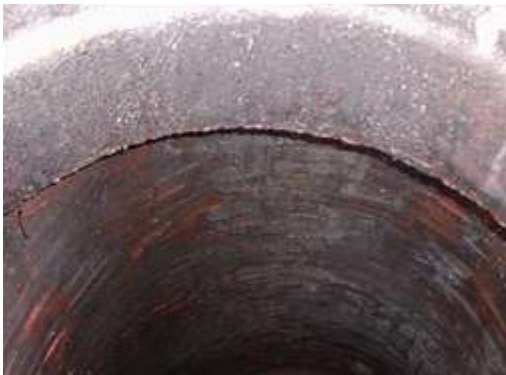
Defect 2

Adjustment Joint

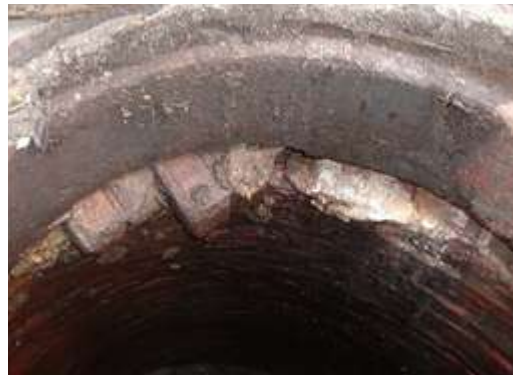
Defect 1

Condition: ☐ Sound ☐ Cracked ☐ Root Intrusion ☒ **Loose Brick** ☐ Deteriorated

Infiltration: ☐ None ☒ **Joint** ☐ Cracks ☒ **Mortar** ☐ Roots ☒ **Wall**

Loose Bricks

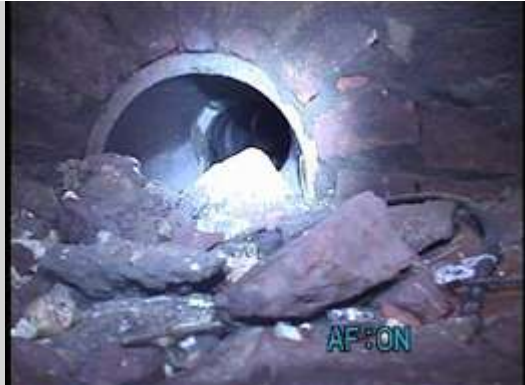
12 O'Clock Outflow

8 in. Circular Gravity Sewer
Pipe Out @ 12 O'Clock
